Jetty Survey

With NORBIT iWBMS Narrow Transmit and iLiDAR

Location: Israel

LIA Engineering and Surveying was commissioned by the **Israel Electric Corporation (IEC)** to conduct a combined survey of a nearshore jetty.

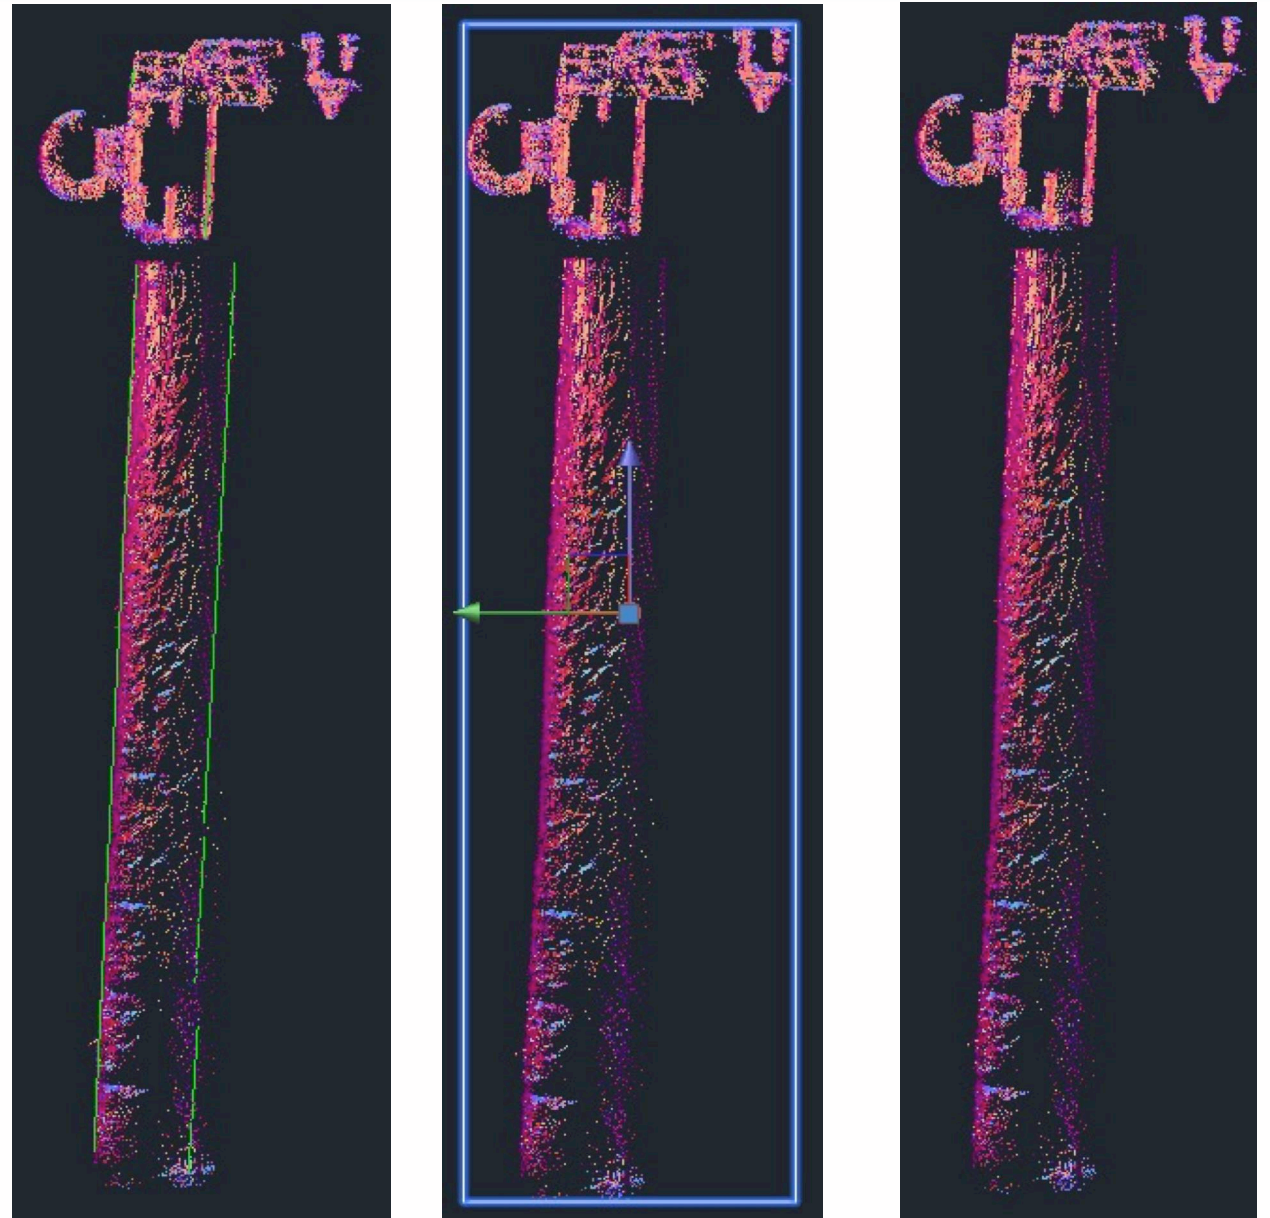
East view 090°

Once the damaged pile was identified, the survey showed with detail, the deformation created in the pile from the collision and allowed us to analyze the orientation of the damaged pile, while the lidar information allowed us to cross check the whole structure in plan view and affirm our findings due to the consistency of the above water movement with the below water deformation.

The damaged pile's orientation is clear when comparing to a perfectly vertical pile.

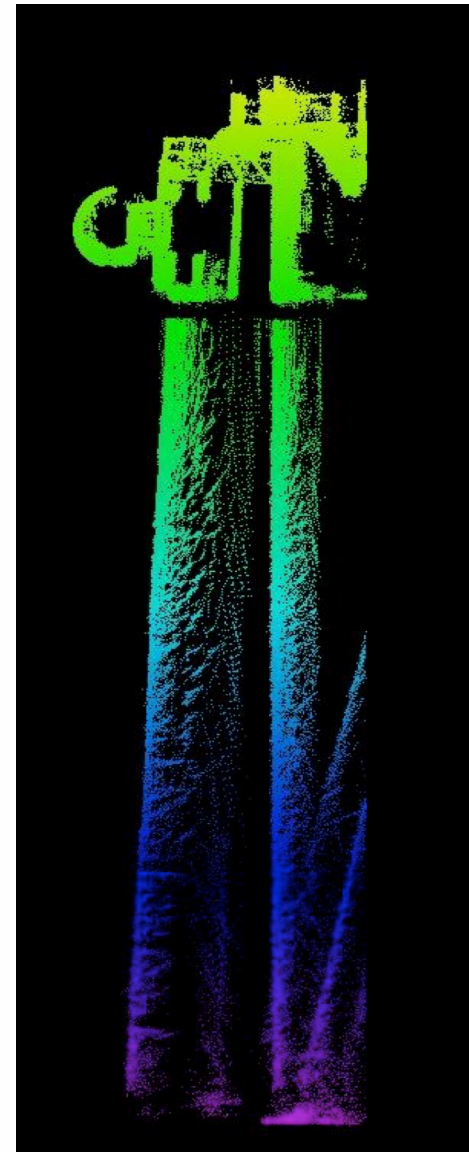
East view 90°

In this dimension, the orientation was harder to determine, yet when comparing to a vertical line the deformation becomes clearer, peak point at approximately mid depth.

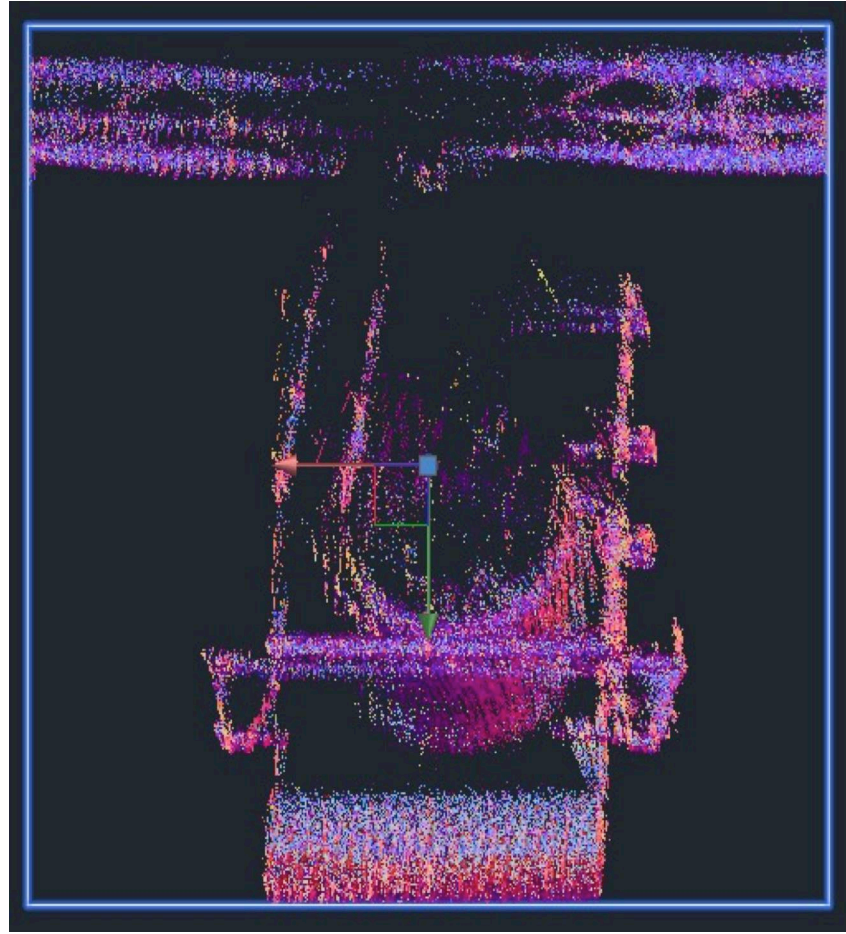
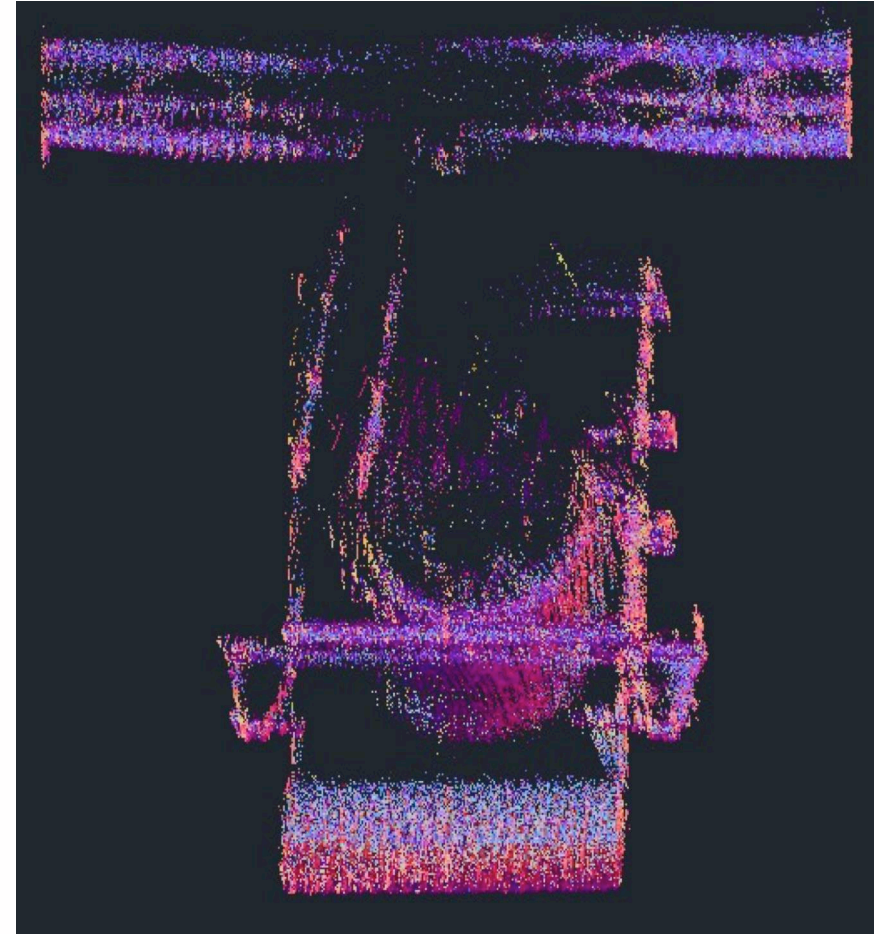
Plan view

The abundance of information allows us to verify our finding, the plan view clearly shows the pile sloping towards north and slightly to the west.

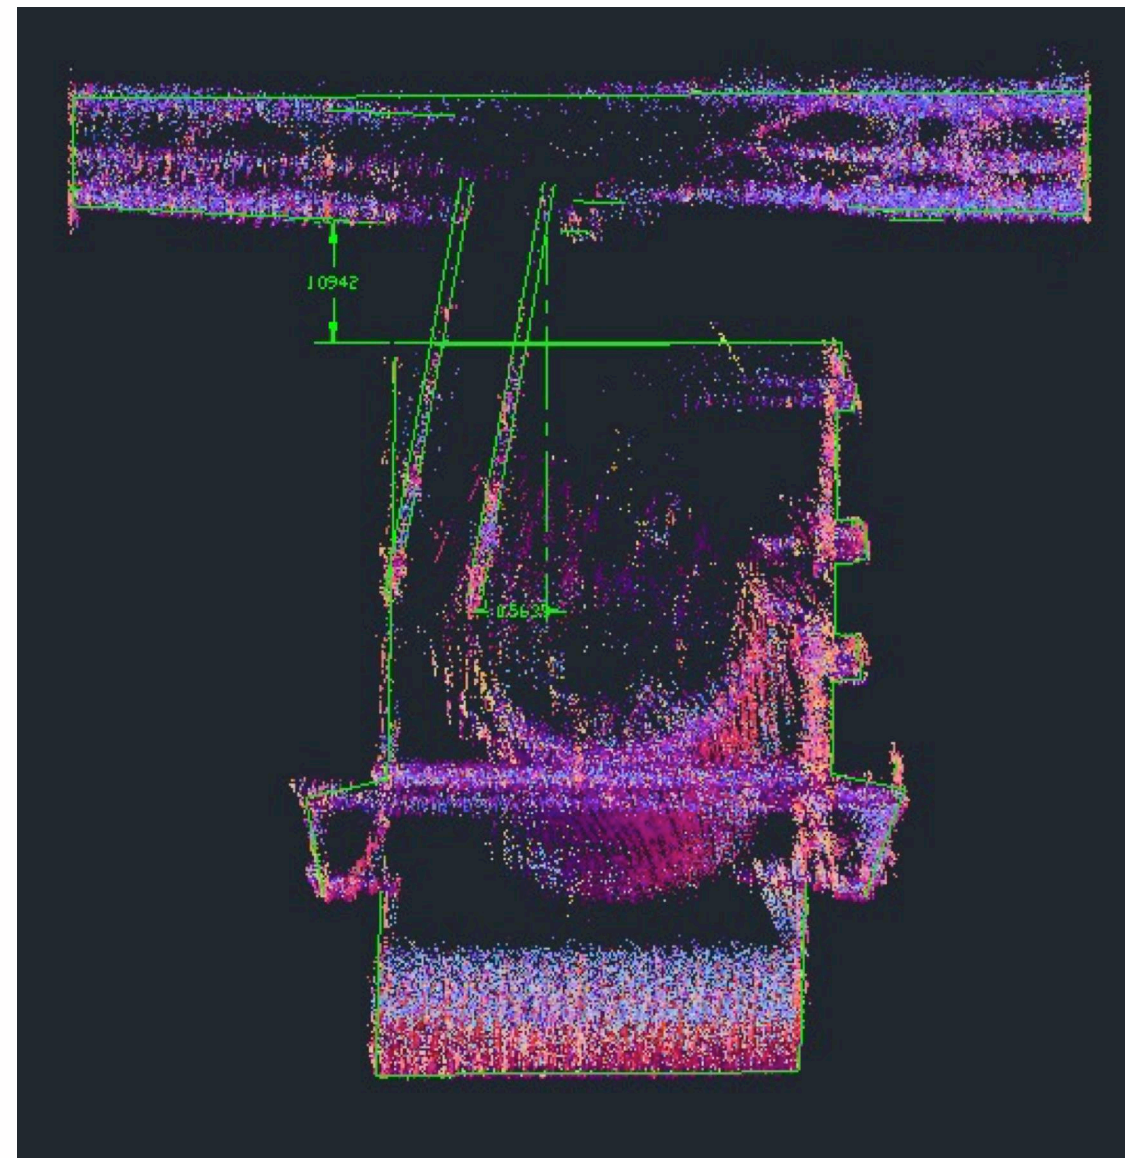
Additionally, the gangway orientation and the distance between the upper platform and the support walkway gives further approval for the finding.
