# USACE Norfolk District S/V Adams II

Technical refresh

# Norbit WBMS Hull Mount

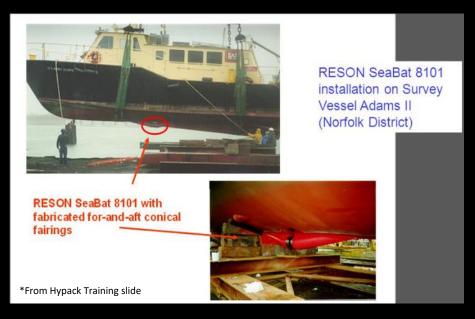
## Original Hull Mounted System, Reson 8101

US Army Corps of Engineers The ADAMS II: launched in 1997 with a Reson 8101 hull mounted on the keel of the vessel. Upgraded to 7101 in 2012. Retired with Norbit WBMS in 2016.

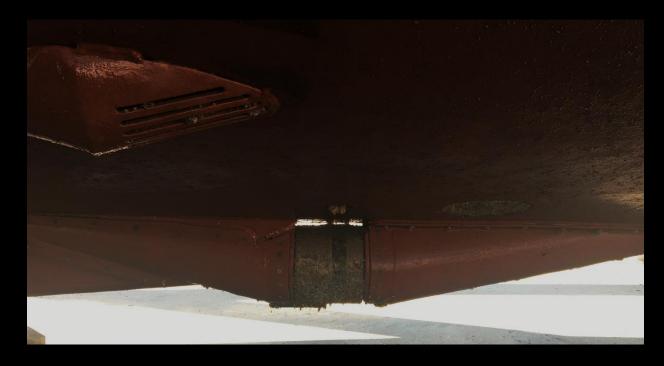
#### **Reson Replacement – Norbit WBMS w/1° Tx**

- Curved receiver array
- Titanium corrosion free housing
- Small beam angles:
  - 200kHz 1.8° X 1.9°
  - 400kHz 0.90° x 0.95°
  - 550kHz 0.65° x 0.69°
  - 700kHz 0.51° x 0.54°
- Swath width anywhere, any size within 210°
- Native FM with 80kHz bandwidth
- Integrated AML SV Xchange probe
- Single thru hull cable
- Compact topside
- Anti fouling paint factory applied
- Safe transit speed: max 30knts

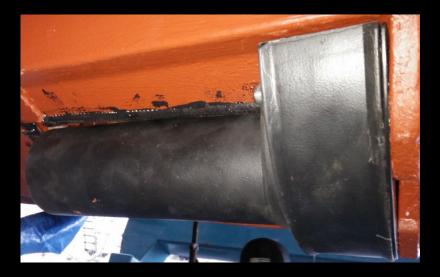
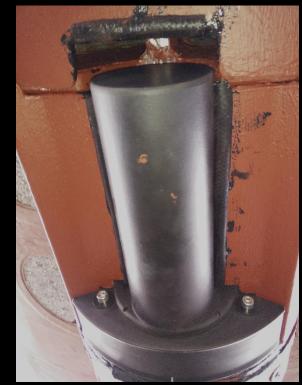
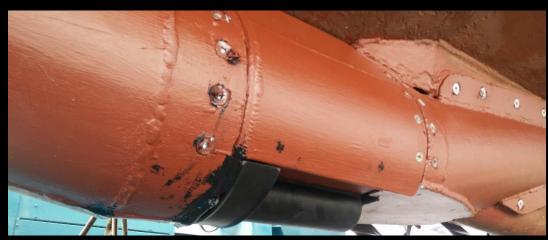
#### **Norbit WBMS Mounting**

Single cable connection for power, bathymetry and surface sound speed data.

The small size of the WBMS allows it to be securely attached to the vessel with two stainless steel bolts.

5200 was applied around the sonar to smooth out any potential cavitation points in the fairing as well as to reduce gaps to aid in water flow.

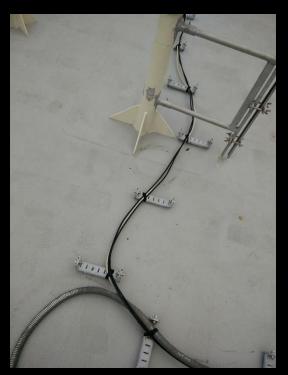
A tidy cable tray with only needed cables.

Over the years many system have come and gone aboard the Adams II. Many of the cables have not, creating a rats-nest.

Seahorse Geomatics removed over 500 linear feet of unused cable. More than 10 separate unused cables were removed from the roof alone.

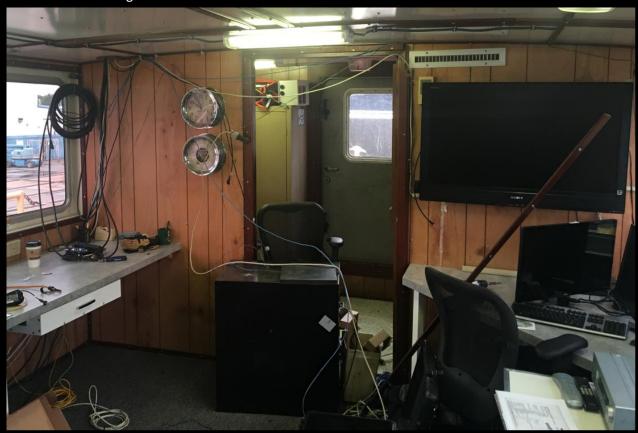
Just starting to remove the cables

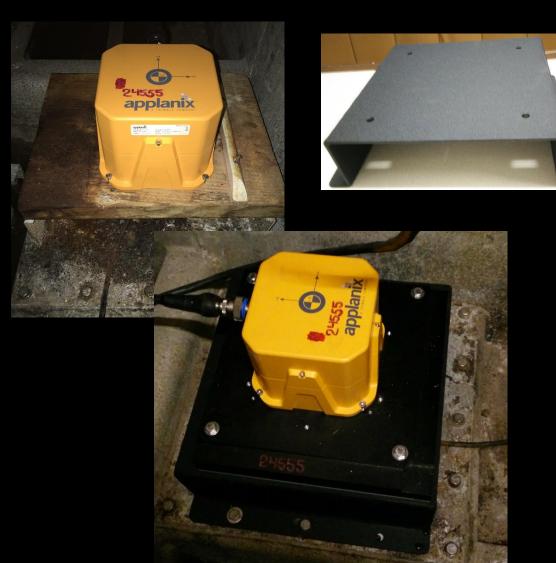
### **IMU Mounting**

IMU previously mounted to wood held up by thin metal struts.

IMU mounting area thoroughly cleaned and prepped prior to installation

Seahorse Geomatics and Dishman Fabrication designed new mounting plate utilizing 3/8<sup>th</sup> aluminum allowing the IMU to sit over the top of the singlebeam which is located less than 2ft from multibeam sonar.

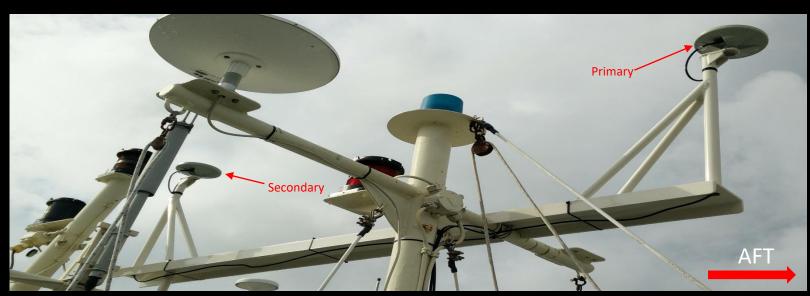
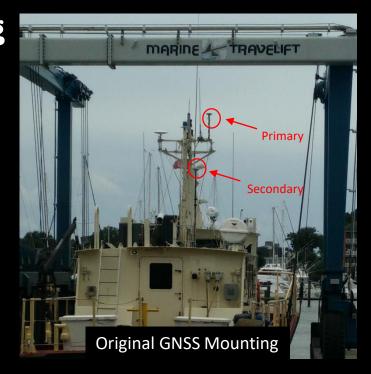
#### **Applanix GNSS Antenna Mounting**

Two problems that were identified for the original GNSS antenna mounting.

- 1) The antennas were vertically separated by more than a meter
- 1) The aft antenna was mounted on a two meter rod and not ridged with respect to the forward antenna and IMU.

Seahorse designed an antenna mount addressing these problems. The new antenna mount was secured to the two masts on the vessel and raised the antennas above any obstructions that may interfere with GNSS reception.

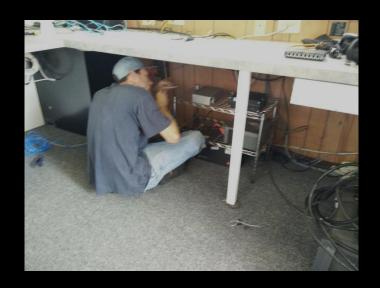
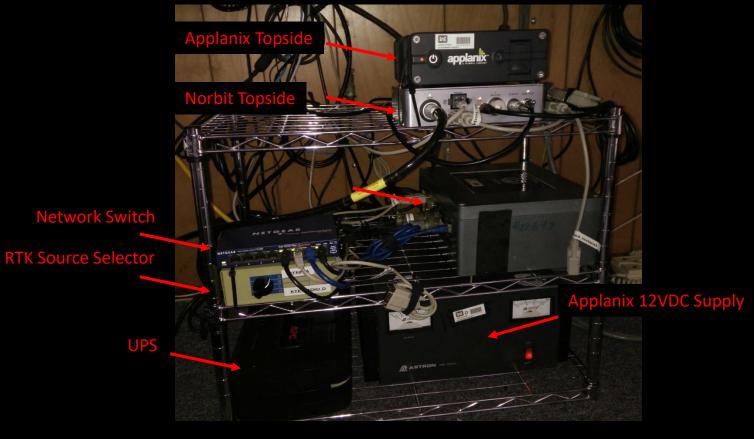
#### **Survey Station – Equipment Rack**

Removal of large Reson topside allowed for significant space savings. Both the Norbit topside and the Applanix topside occupy less than a quarter of the shelf space.

All system are connected through a network switch with a single network connected to the acquisition PC.

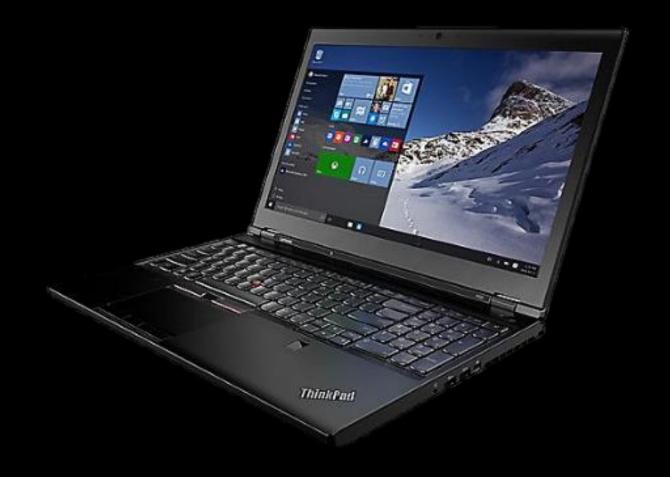
#### **Survey Computer**

The Norbit WBMS requires minimal computer processing during acquisition. However Hypack 2016a has a better processing experiences when more RAM and a faster processor is available on the computer.

To fill the role of both acquisition and processing, a Lenovo P70 was chosen. The computer allows the Norfolk district to seamlessly switch between acquisition and processing, decreasing the time to deliverables.

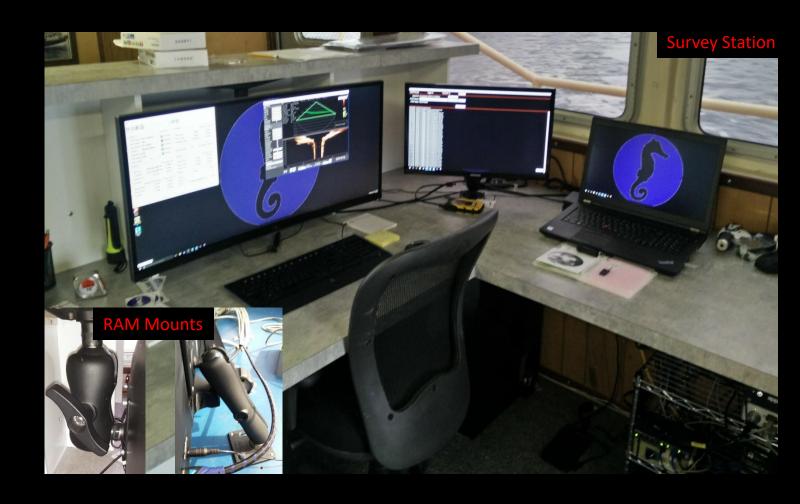
#### **Survey Station – Computer Station**

Laptop secured to docking station for fast removal.

New displays were added to the survey station and the wheel house.

- Dell 34" curved monitor
- Three Samsung 22" monitors (two for helm)

Operators have the option to use the laptop screen as a 3<sup>rd</sup> display or close it, using the 2 main displays.

The displays are secured to the vessel using RAM, ball and socket, mounts. These mounts securely hold the screens in place yet still allows for minor adjustments. During heavy seas the screens remain in place allowing for a safer working environment.

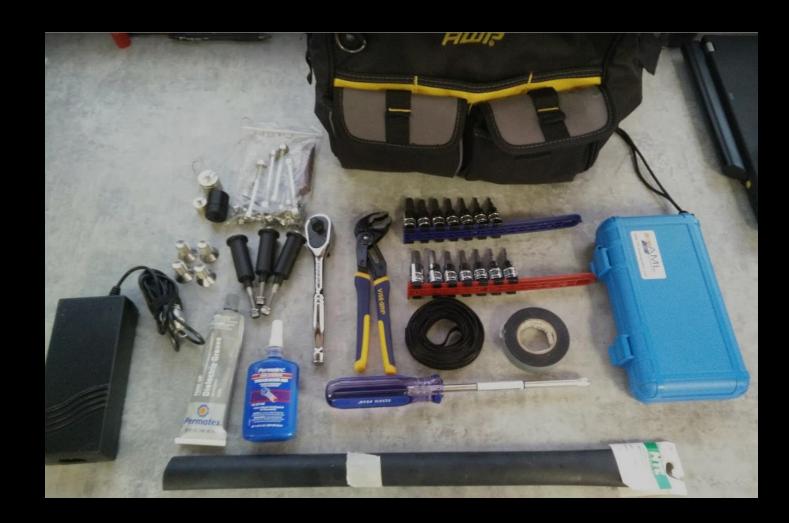
#### **Survey Systems Tool Bag**

Seahorse provides a customized tool bag. Included are all needed tools and spare/backup parts that the crew of the Adams II may need for their survey systems.

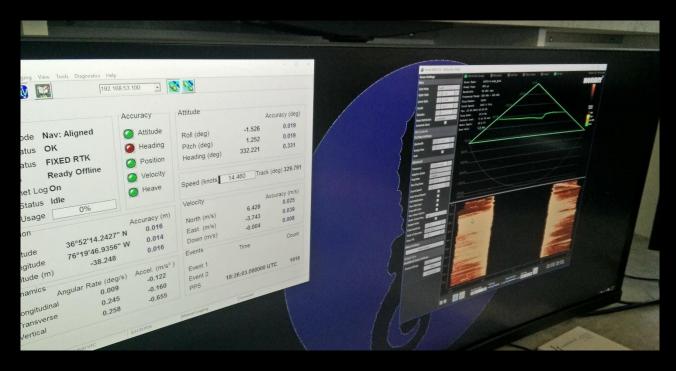
#### **Performance - Speed Test**

To determine the operating envelope of the WBMS onboard the Adams II a speed test was conducted. The test consisted of incrementally increasing the vessel speed and monitoring for 3 primary items.

- 1) Bathy data blowouts indicating that cavitation is occurring around the sonar.
- Loss of outer beams indicating that bubble sweep down could be affecting the SNR of the outer beams.
- Loss in surface SV readings indicating that bubbles are accumulating inside the fairing obstructing the SV sensor from proper measurements.

Speed test results indicated that there was no cavitation, bubble sweep down or loss of SV readings and therefore no speed limitation on vessel operations.

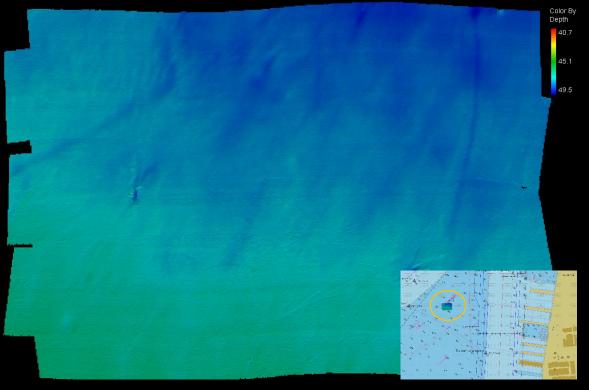
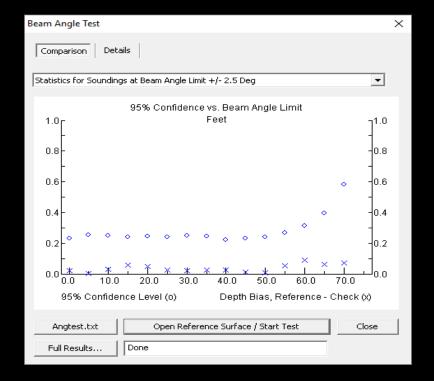
#### **Performance – Beam Angle Test 400kHz**

To assess system performance a series of beam angle tests were conducted in approximately 50ft water depth.

System bias was <0.1ft and uncertainty at 95% confidence was <0.6ft allowing the USACE to utilize a 140° swath angle
