NORBIT
- explore more -

Shipwreck survey

Budapest

In November 2019, a NORBIT team completed a bathymetric and FLS sonar survey around the barge wreck.

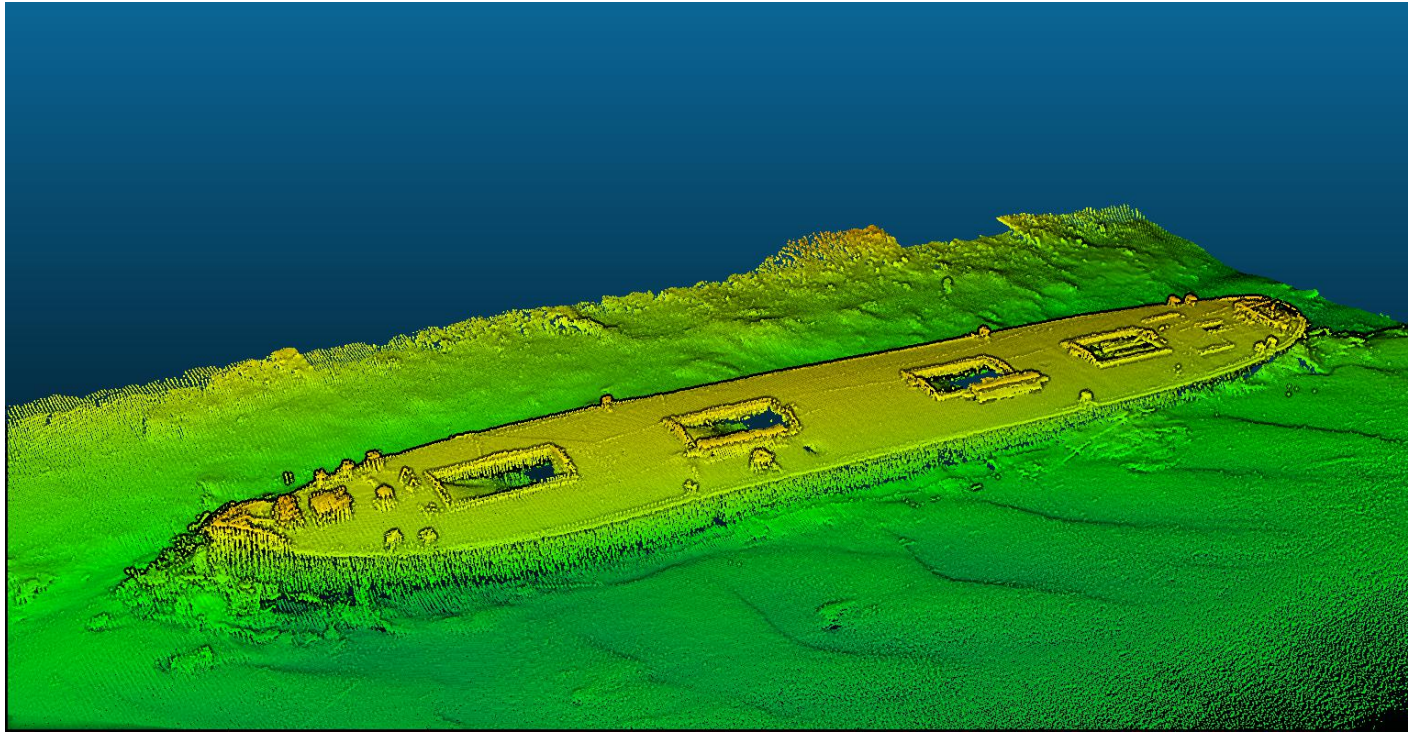
iWBMS multibeam bathymetry - sonar data – 400kHz

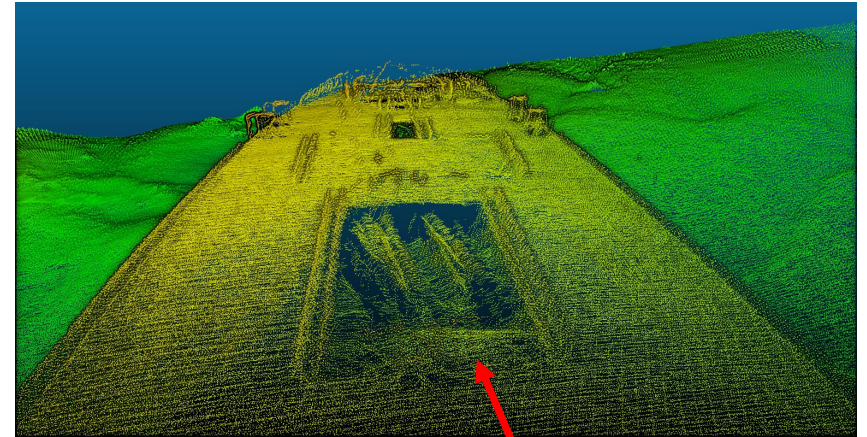
Logs inside the hull are visible on the bathymetric image

- The Hungarian Defense Forces, with fifty people, including twenty divers, and two de-mining boats, took part in an action organized by the Defense Forces, to investigate the barge.
- Divers found mud in the middle of the barge and thought it might contain bombs or ammunition.
- The underwater investigation also included photos and video footage of the Army divers, who also exposed a large wooden pole from the ship. From what the divers saw, it was easy to imagine that the first diver might have looked at logs and debris, which could have resembled ammunition in the muddy water.

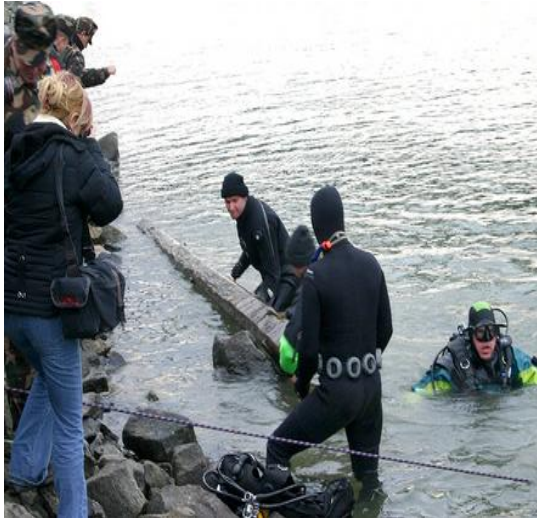
Cargo material and divers during recovery Image credit: index.hu

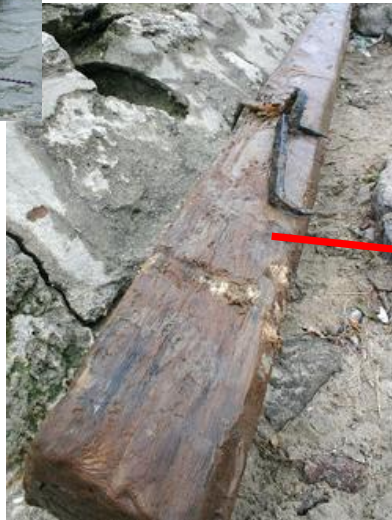
Logs visible in bathy data

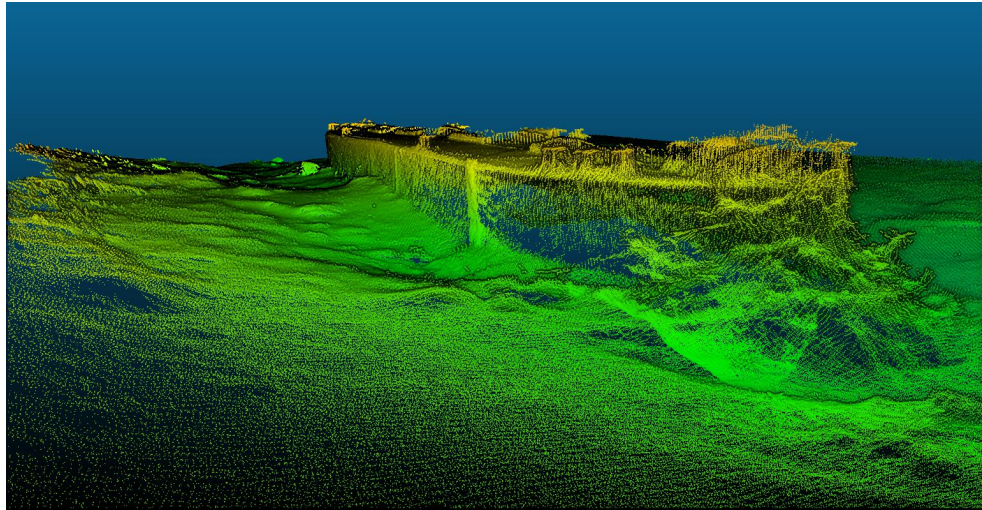
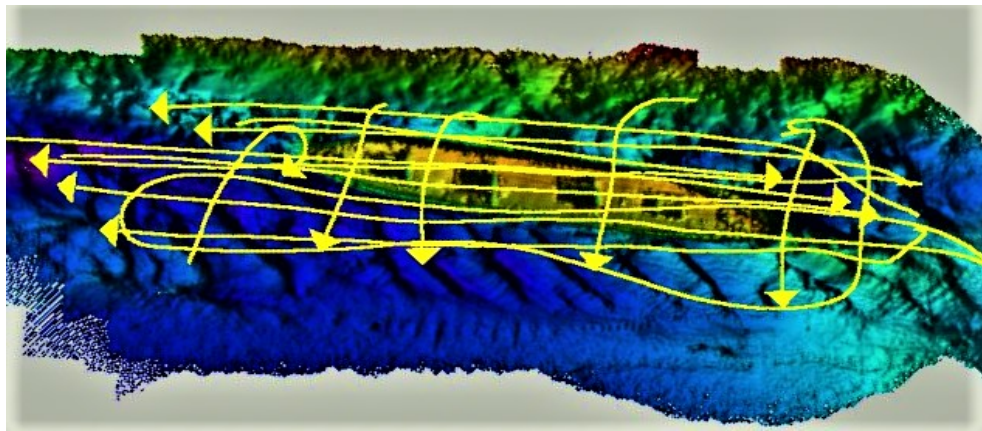
Survey was conducted along parallel and perpendicular lines

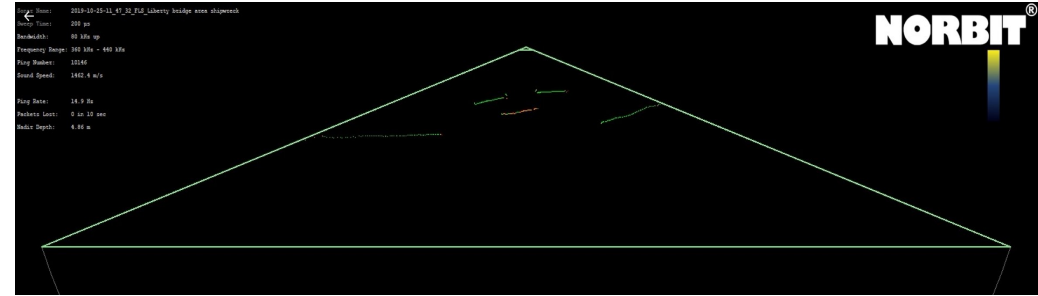
GUI – bottom detections on cargo door openings

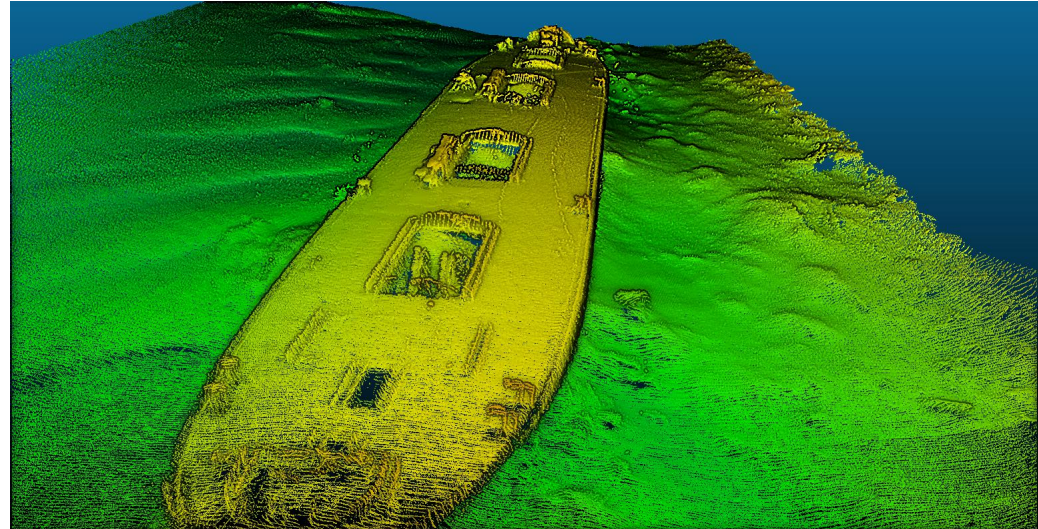
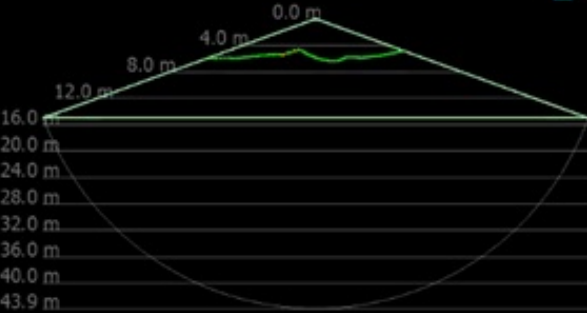
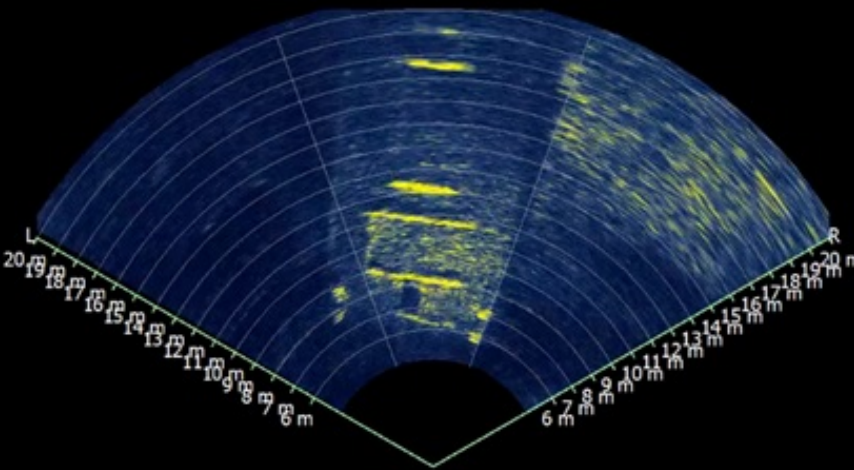
Start Range: 5 m

Opening Angle: 120.0°

Frequency: 400 kHz

Static Gain: 91.0 dB

NORBIT GUI in parallel usage of Bathymetry and FLS sonar
