Painted Rocks Recreation Area, Darby Montana USA
Stilling Basin Survey

Painted Rocks Dam

Survey Purpose

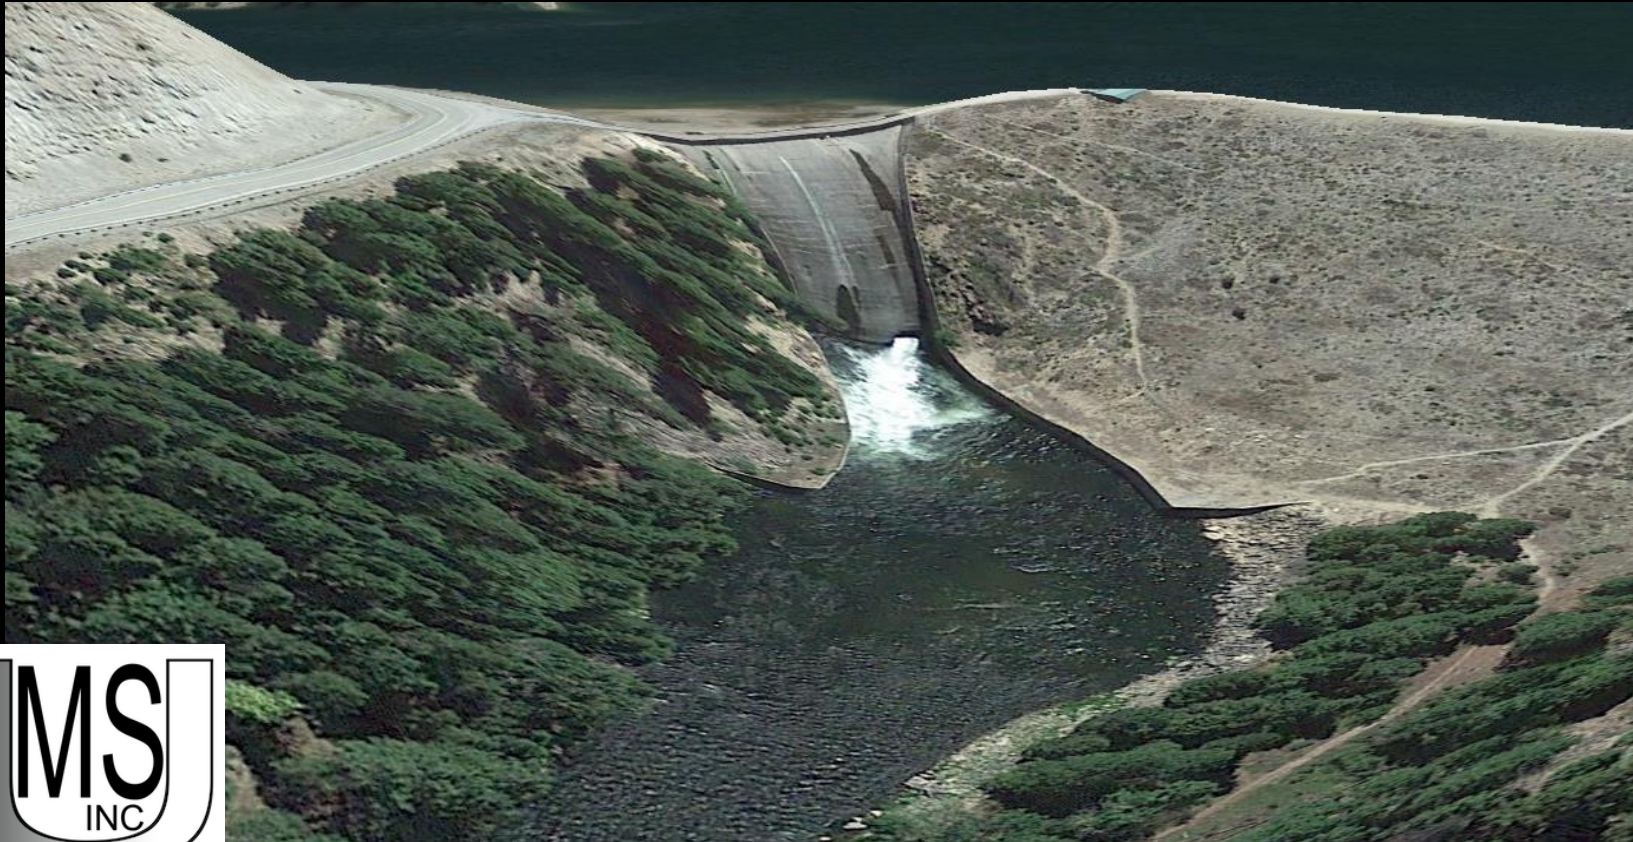
- Plan for future improvements to the dam structure
- Inspect for damage to the baffle blocks and sedimentation in the stilling basin

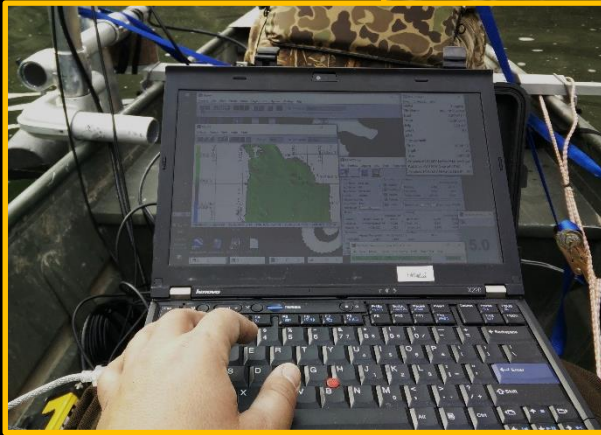
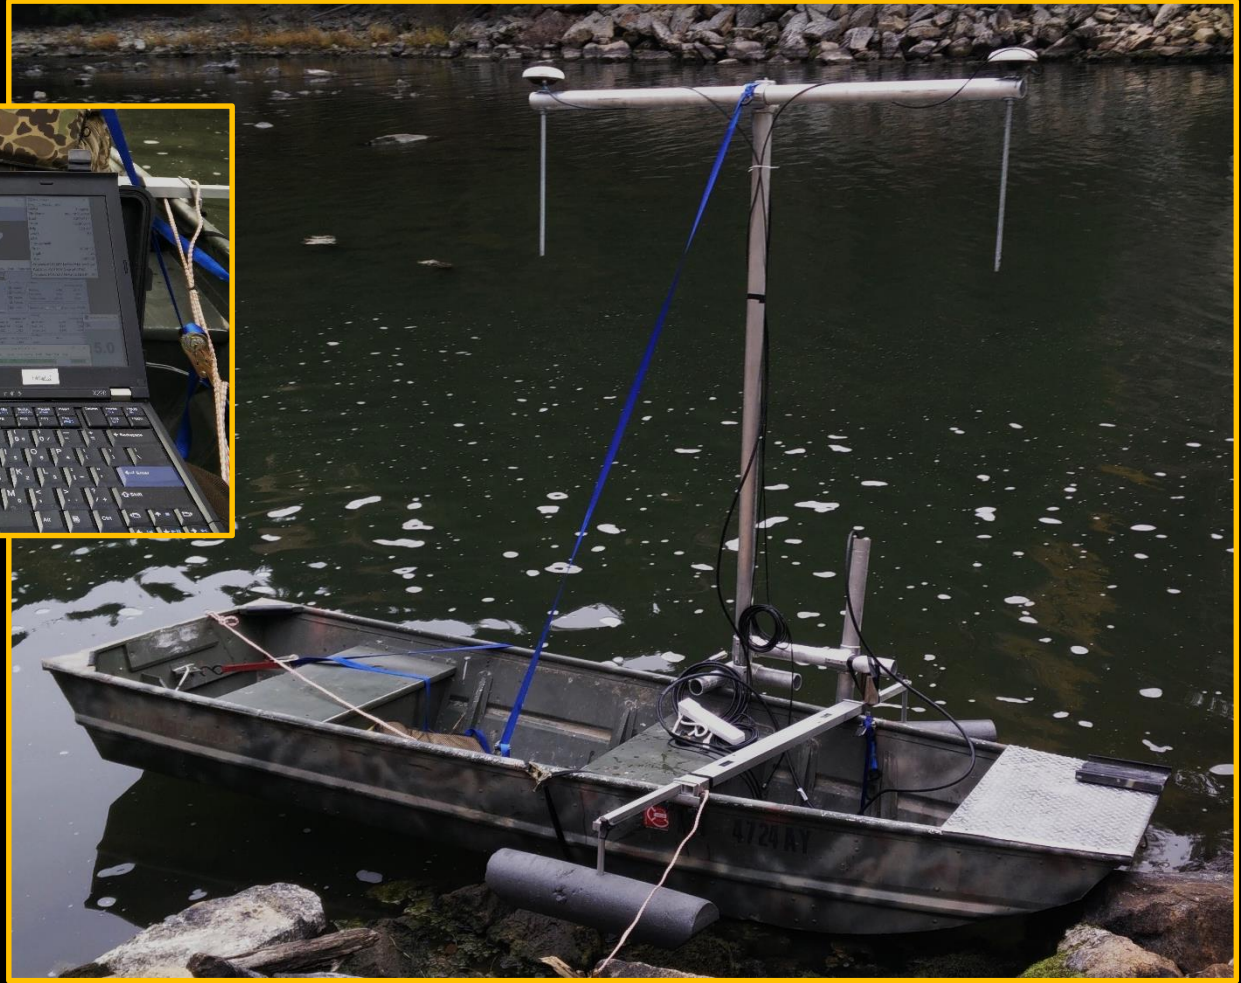
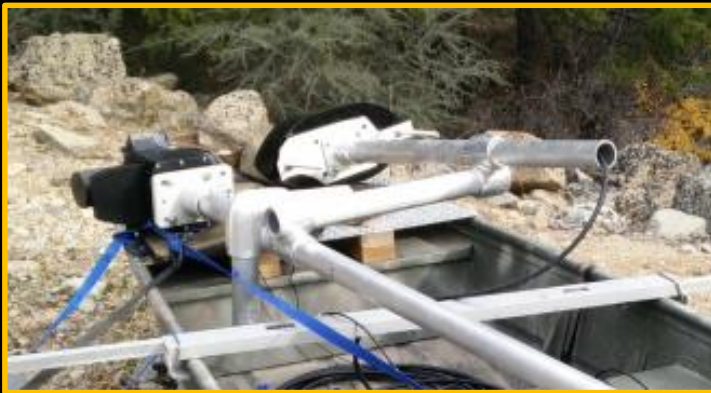
Survey vessel

- 13ft X 4ft flat bottom Jon-Boat
- MinKota trolling motor on bow
- Outriggers (stability)

Norbit iWBMSH mounted to vessel utilizing Norbit Go-Kit. Power for the motor and sonar provided via direct connection to Deep Cycle 12VDC battery. Survey computer powered via internal battery

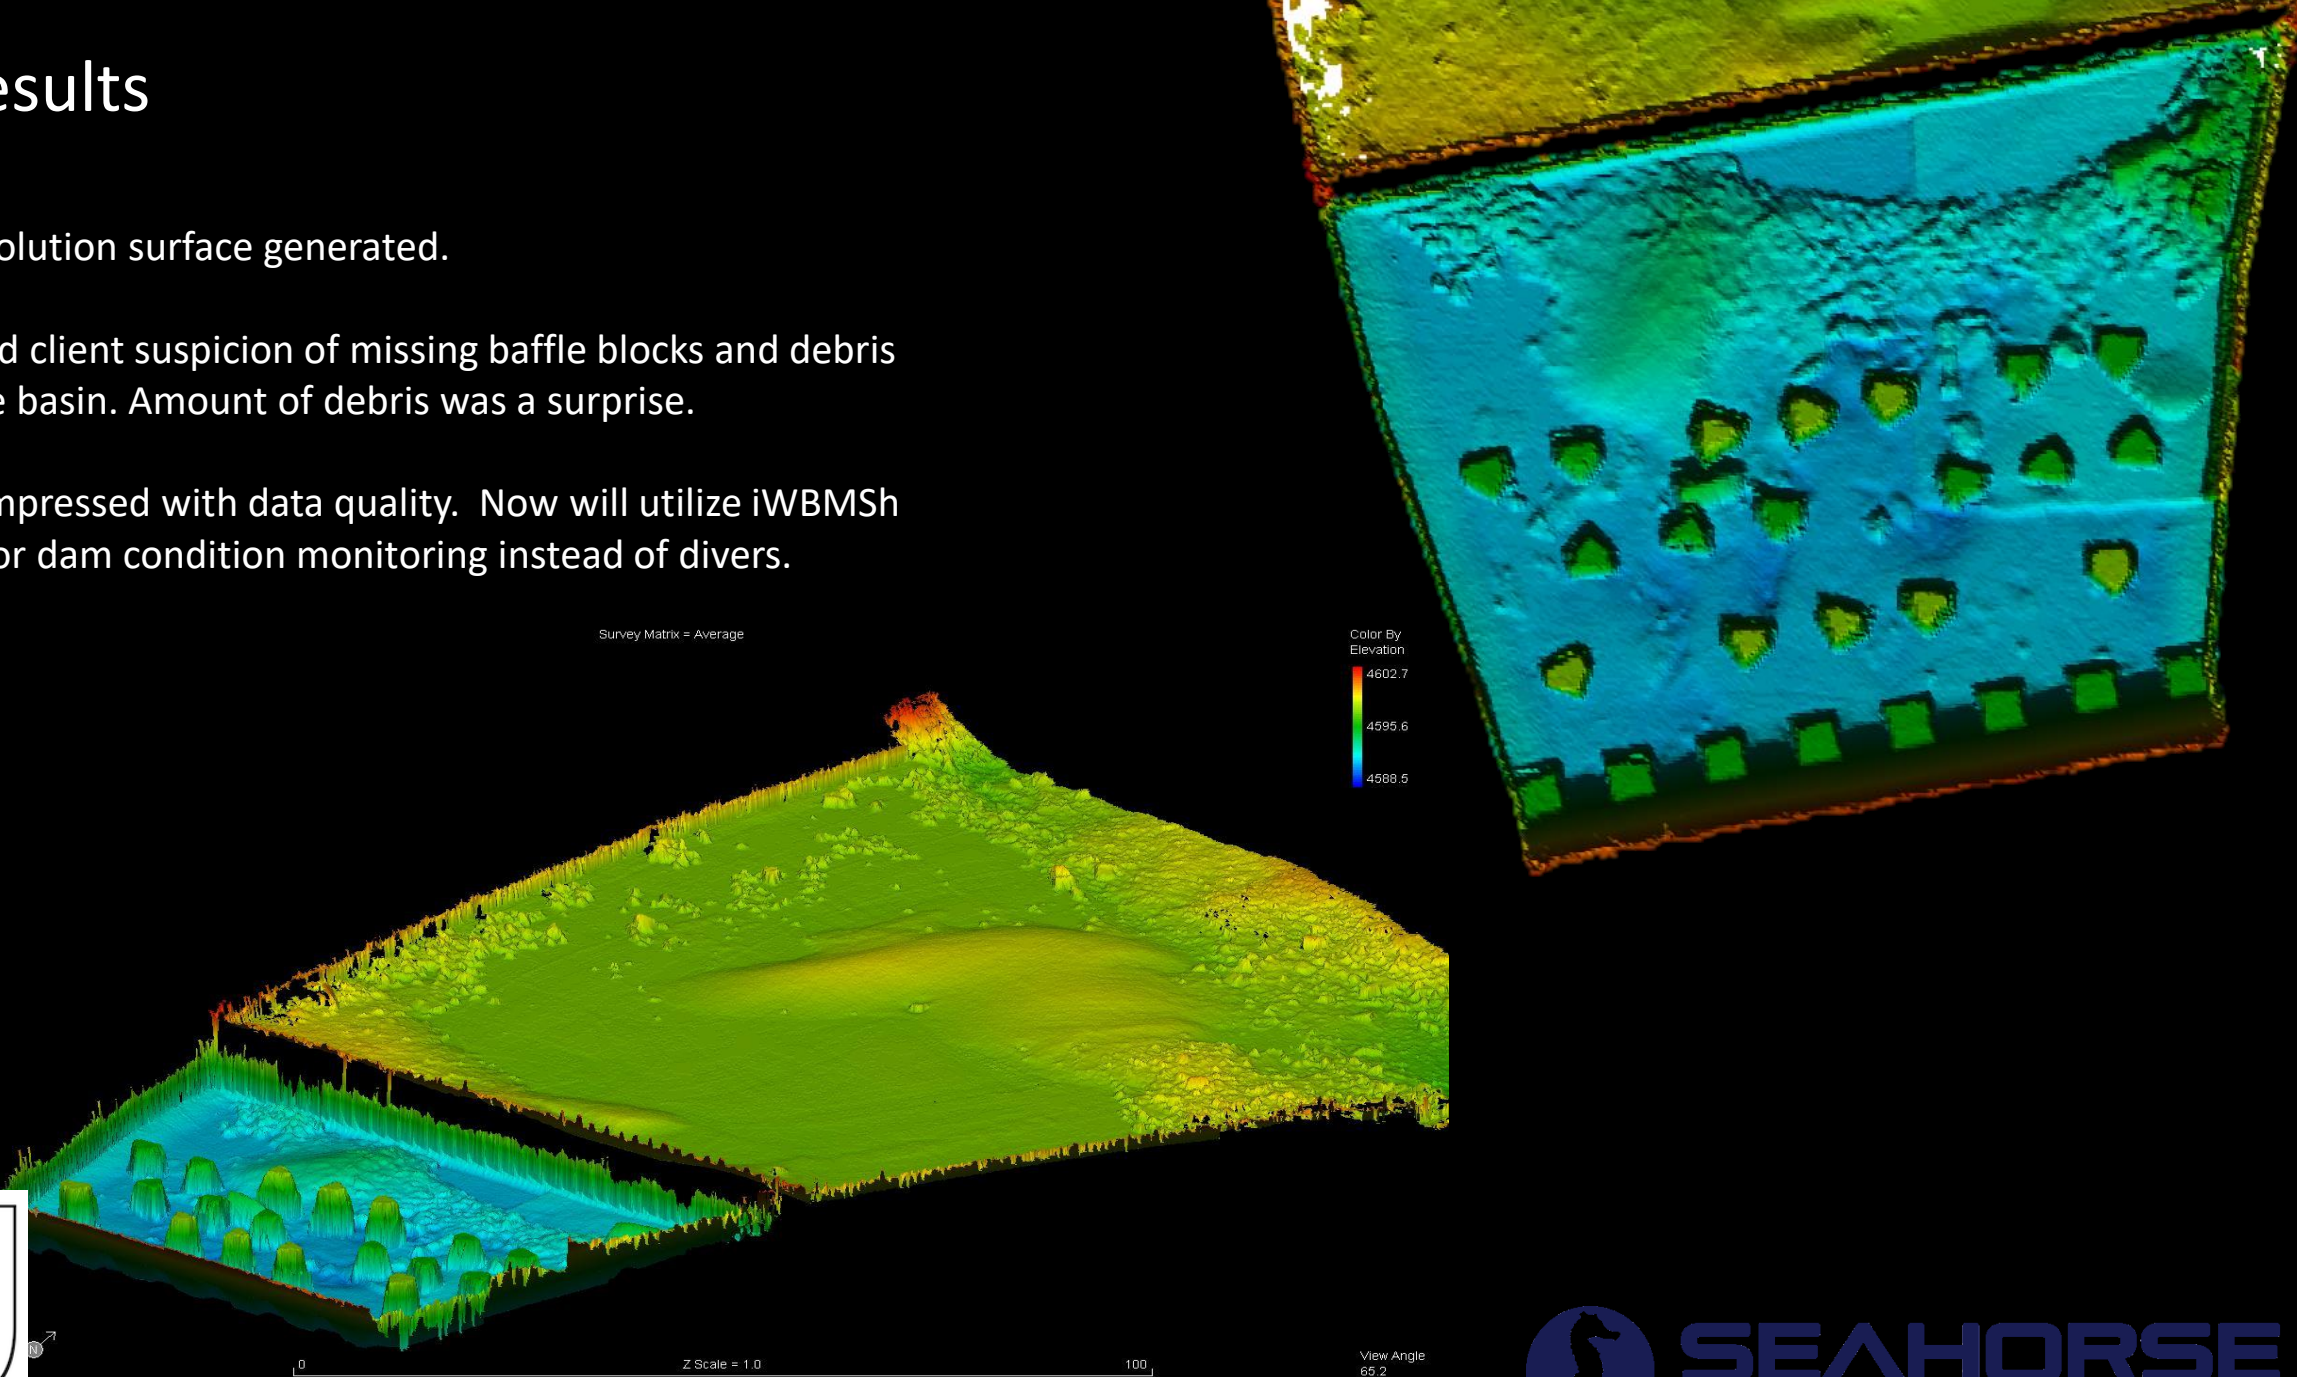
Data Results

- 10cm resolution surface generated.
- Confirmed client suspicion of missing baffle blocks and debris inside the basin. Amount of debris was a surprise.
- Clients impressed with data quality. Now will utilize iWBMSH surveys for dam condition monitoring instead of divers.
