Jetty Survey

With NORBIT iWBMS Narrow Transmit and iLiDAR

Location: Israel

LIA Engineering and Surveying was commissioned by the **Israel Electric Corporation (IEC)** to conduct a combined survey of a nearshore jetty.

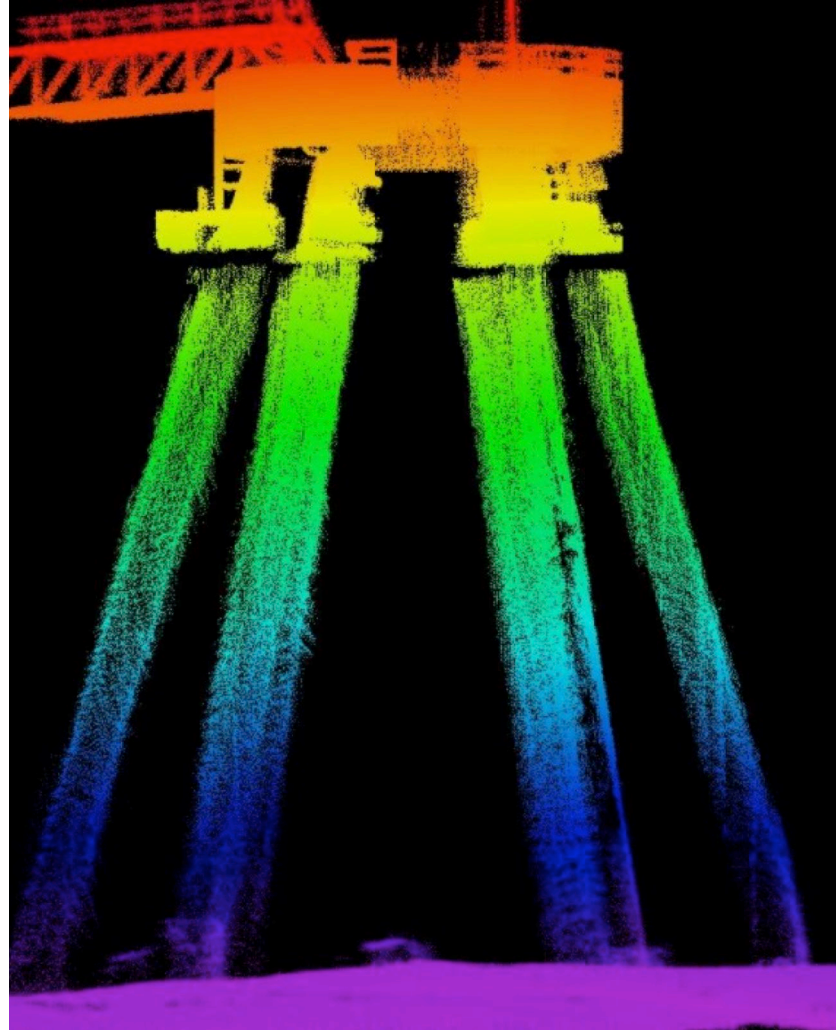
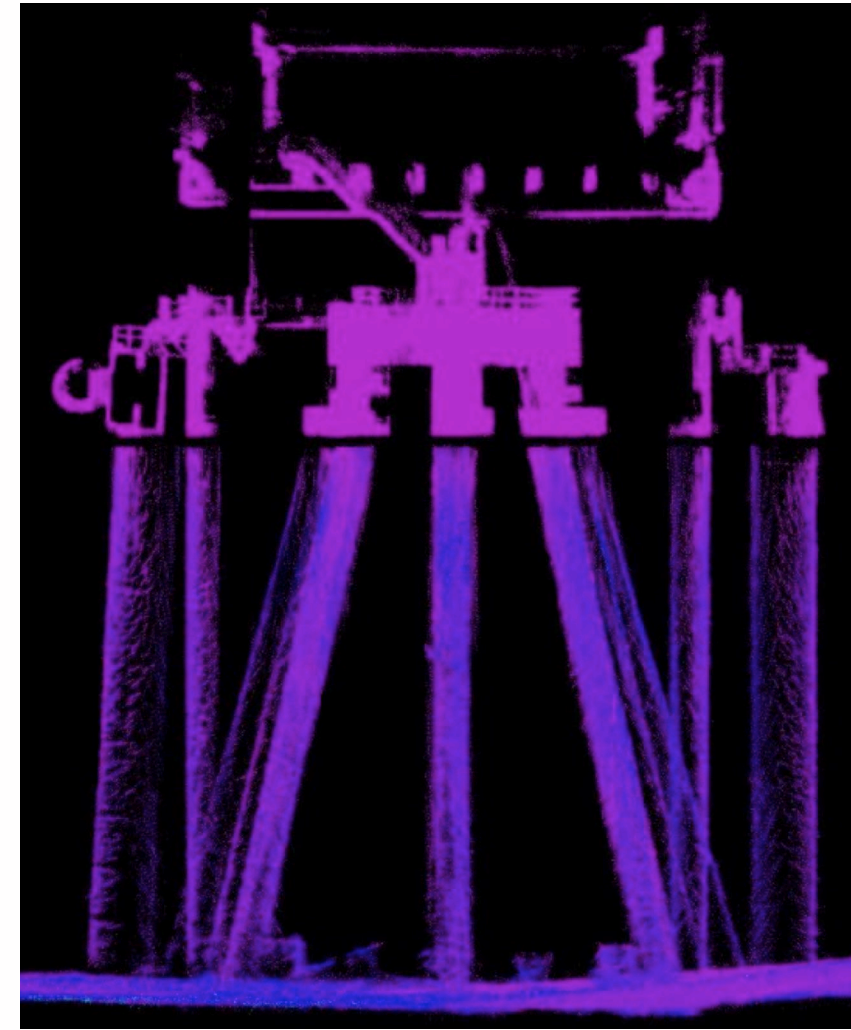
Once the damaged pile was identified, the survey showed with detail, the deformation created in the pile from the collision and allowed us to analyze the orientation of the damaged pile, while the lidar information allowed us to cross check the whole structure in plan view and affirm our findings due to the consistency of the above water movement with the below water deformation.

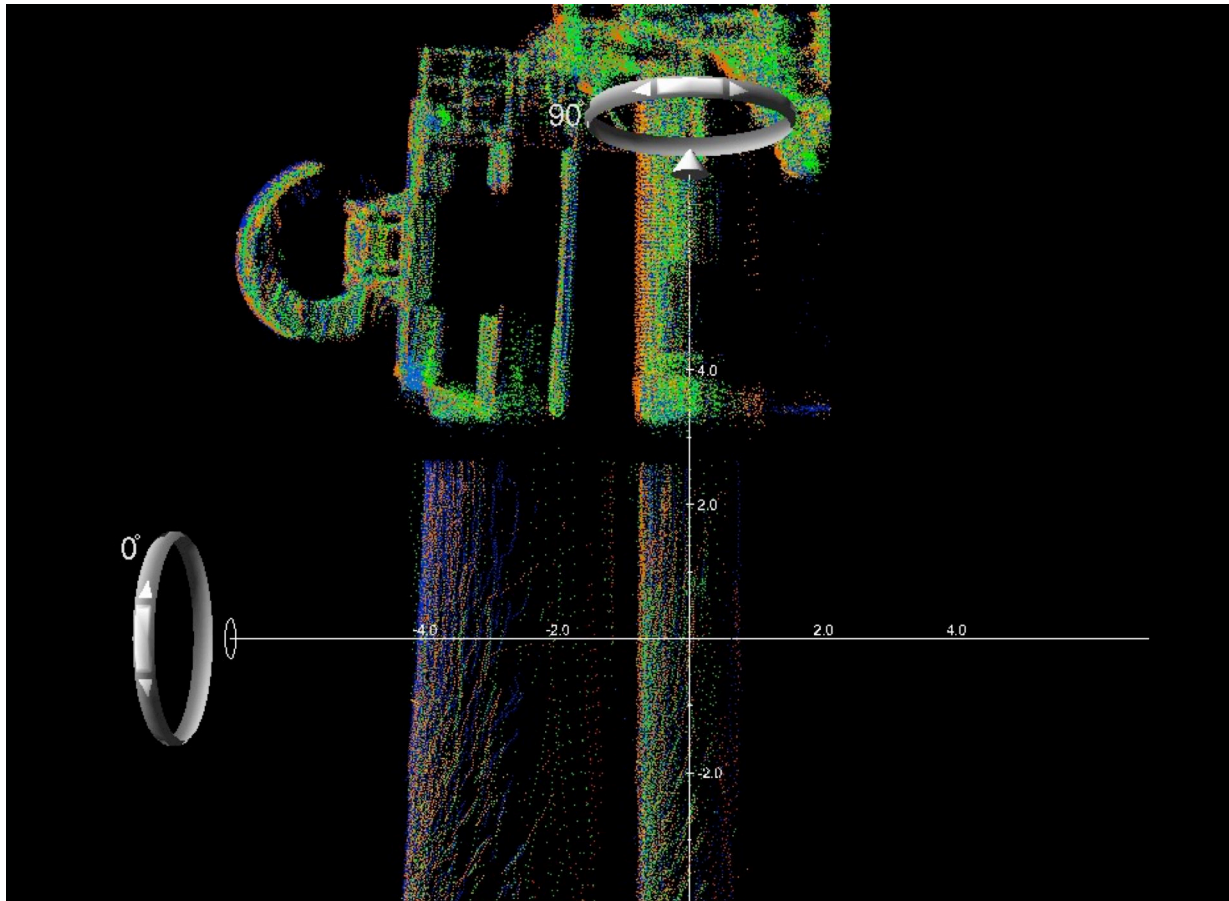
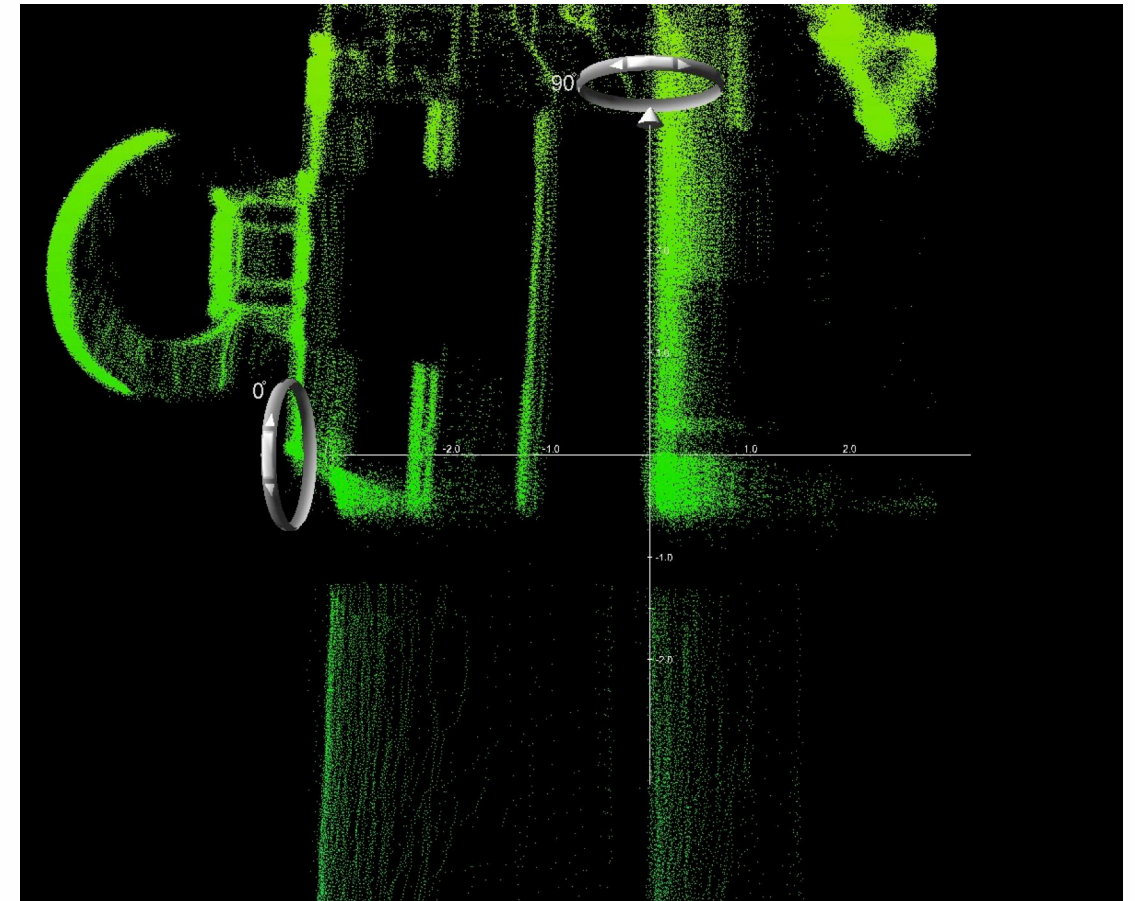
The damaged pile's orientation is clear when comparing to a perfectly vertical pile.

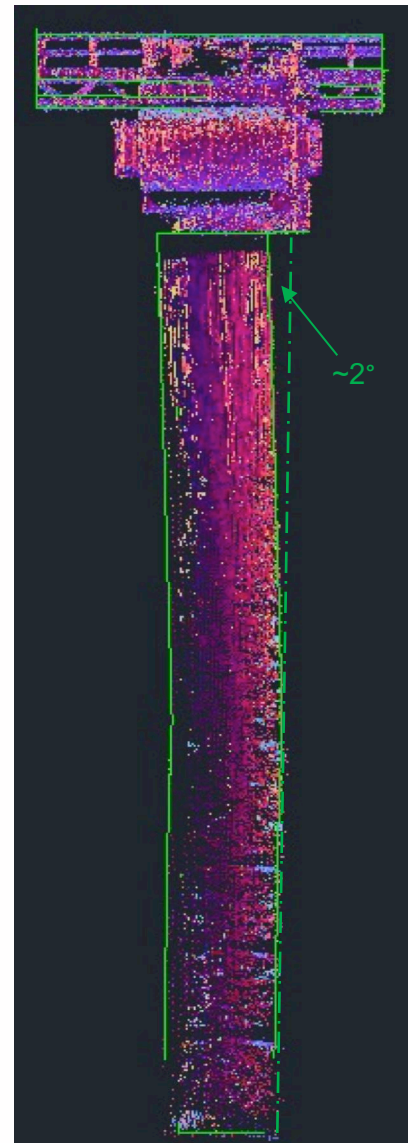
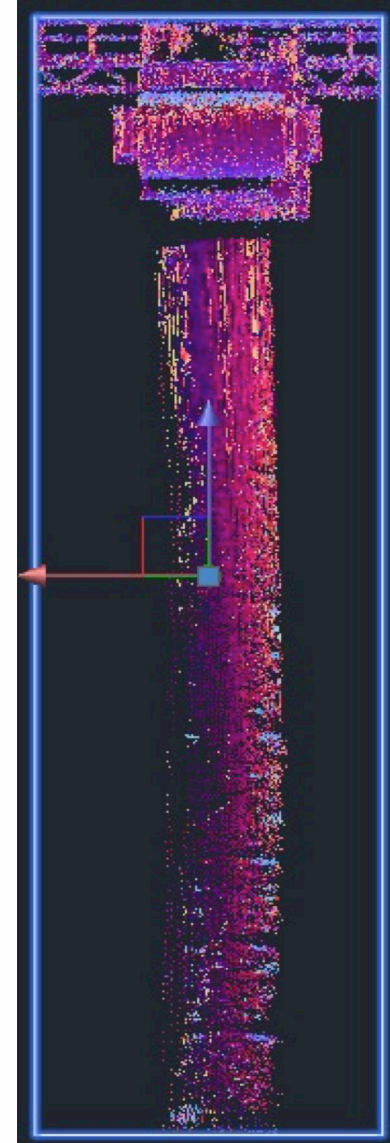
East view 90°

In this dimension, the orientation was harder to determine, yet when comparing to a vertical line the deformation becomes clearer, peak point at approximately mid depth.
